NASA TECHNICAL  
MEMORANDUM

June 28, 1974

NASA TM X-64815

MSFC SKYLAB APOLLO TELESCOPE MOUNT  
SUMMARY MISSION REPORT

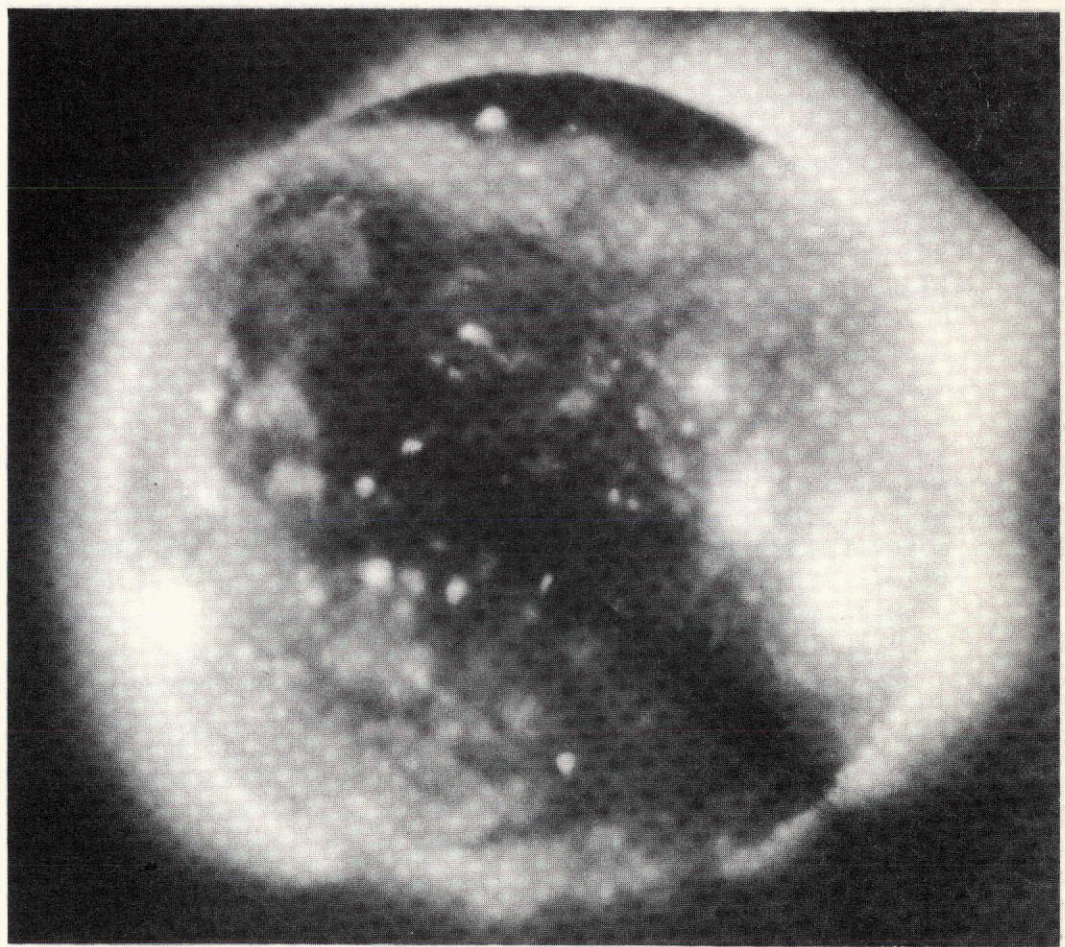
During the Skylab 4 mission, the experiment filter wheel stopped between position 5 and 6. Since positions 5 and 6 were the most dense filters contained in the experiment, data taken during this period were limited to features with relatively high surface brightness. During extravehicular activity on DOY 359 the crew manually rotated the filter wheel to position 3 (clear). During the repair procedure the shutter blade became disabled and had to be bent out of the light path. The bent shutter blade later moved into the light path and caused some image degradation as shown in figure 3-8. Exposure durations were subsequently controlled by selection of film transport intervals. Although operation with the shutter constantly open produced some image blurring on the shortest exposures, it allowed two modes of operation that provided better temporal resolution and data correlation with the S052 experiment.

Figure 3-8. Degraded solar Image Caused by Bent Shutter Blade

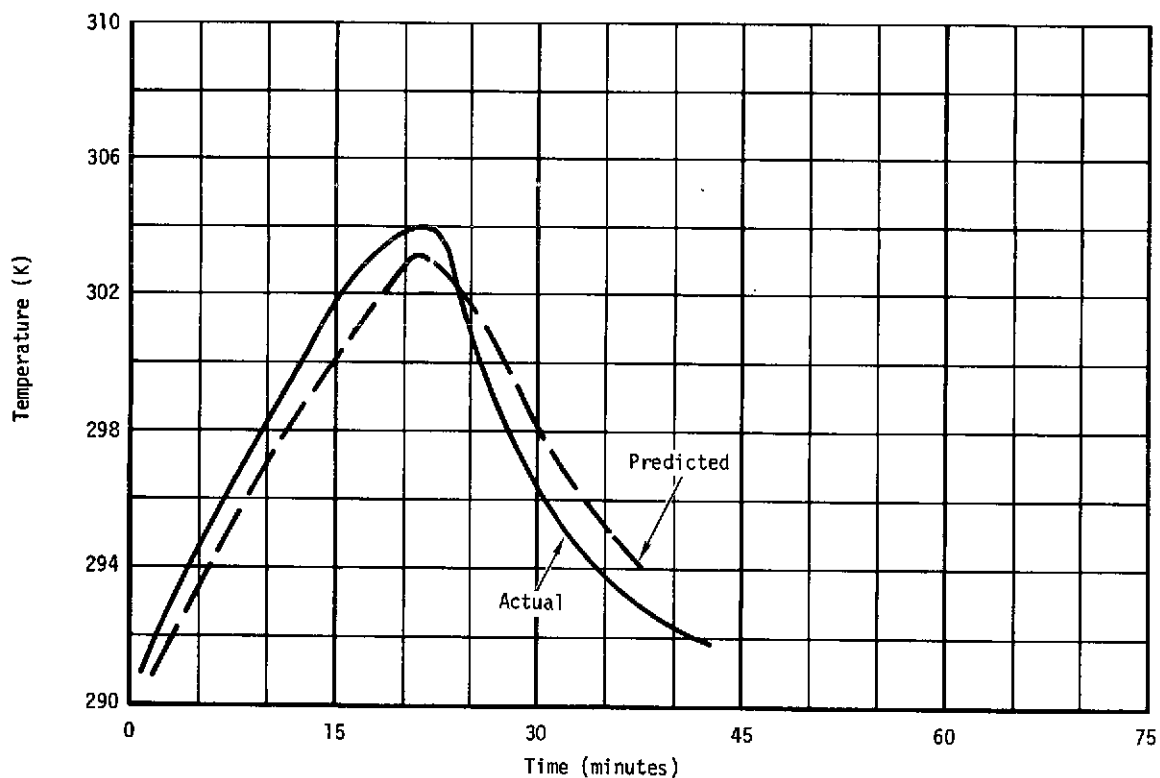
Figure 4-1. S052 Camera Temperature During Stall on SL-2

S052 Camera Jam and Torn Film - On DOY 161 an unusual rate of temperature rise was observed inside the film camera. The rate of rise was comparable to that derived by computer simulation for a stalled film transport motor. This comparison is shown in figure 4-1.

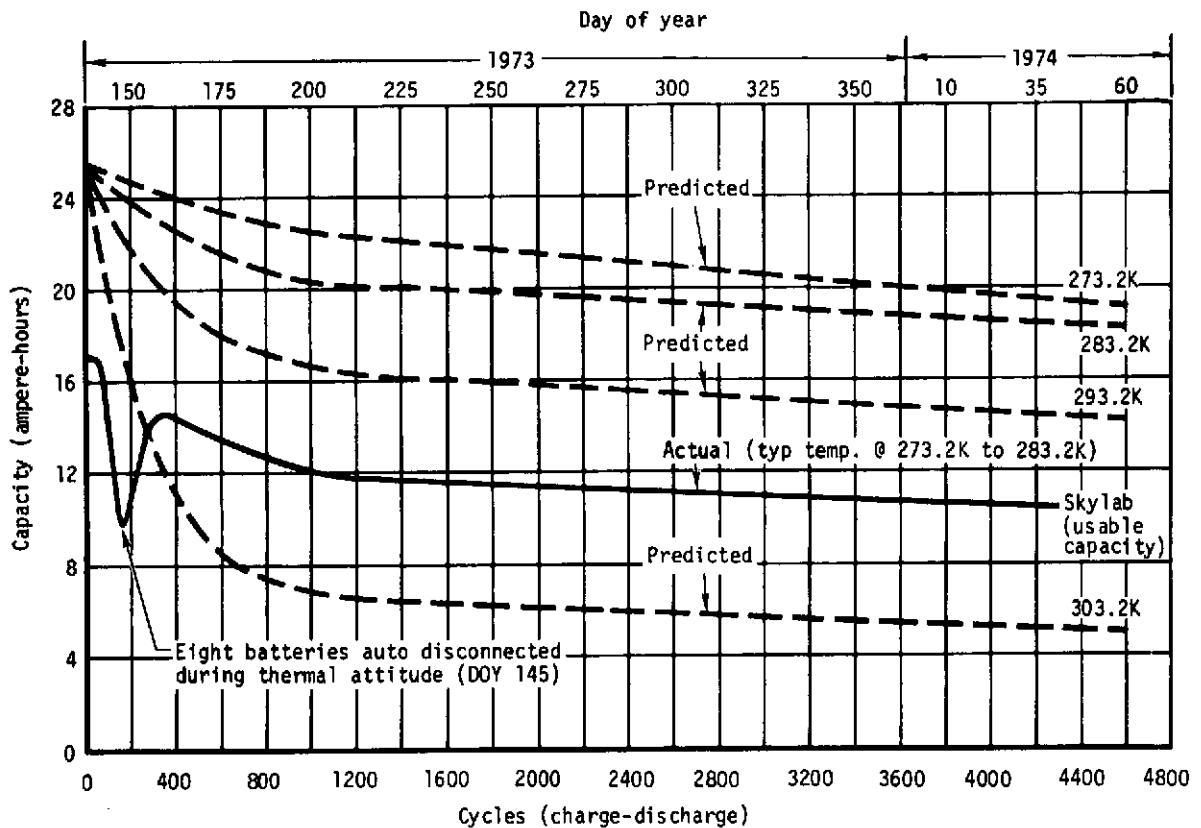
Figure 4-5. ATM Battery Capacity for Skylab Mission

Subsequent capacity checks on DOY 255 (11 ampere-hours) and on DOY 362 (10 ampere-hours) indicated that the available capacity increased slightly after DOY 150 and remained relatively constant during the remainder of the mission. Although the capacity loss did not seriously affect the mission, it was an anomaly that was unexpected and unexplained. Battery aging, as a result of pre-launch testing and cycling, had caused degradation greater than anticipated. Figure 4-5 shows ATM actual and predicted battery capacities were lower than anticipated. There was no impact on the Skylab mission, since a power margin of not less than 800 watts existed after DOY 158, when the Orbital Workshop wing was deployed.
